Why is my Wireless Device or Processor Receiving a Low Memory Error?

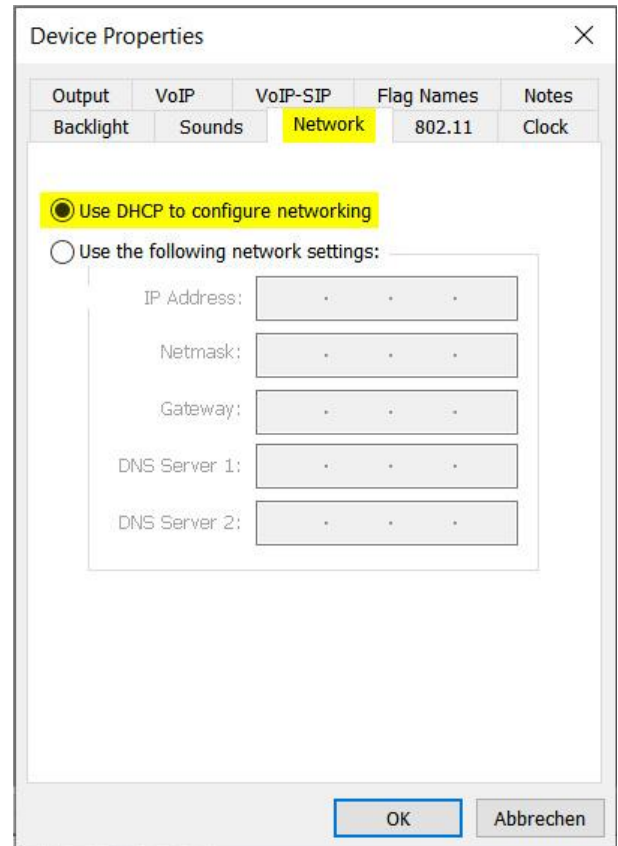
2. “Program Memory Low” Message on Wireless Devices (Remotes & Touch Panels)

A low memory error on a wireless device happens due to a network communication error. Usually it’s due to Wi-Fi but if the WiFi is disabled it means that the issue is related to the IP address of the device on the network. In most cases, a static IP has been set and the network is finding a conflict with the IP address.

If the device is already configured to utilize DHCP, the DHCP server within the router is having troubles assigning it due to a limited number of slots or a detection of an already assigned address at the next slot that the DHCP server should be assigning it. It is most common in networks containing many IP assignments moving on/off the network regularly.

First, attempt to change the network option in the device configuration to “DHCP” (as opposed to Static IP) which should resolve the issue.

For CX/KX touch panels: It is not recommended to utilize Ethernet/ LAN & WiFi simultaneously. In order to avoid IP conflicts disable the WiFi adapter in device settings if connected via ethernet. The device only uses a single connection for communication.

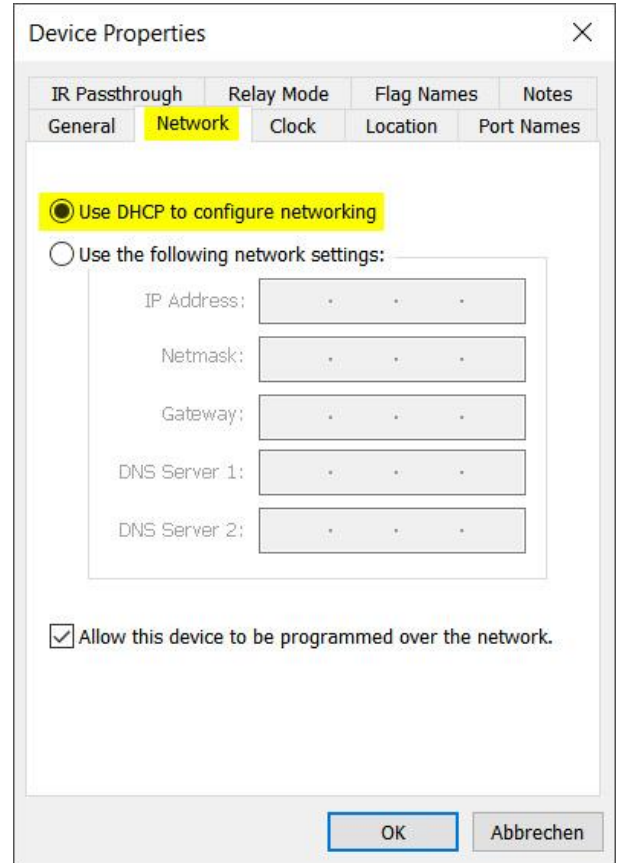
3. “Program Memory Low” on the XP-8v On Screen Display (OSD)

When the XP-8v displays “Low memory” on the display screen, this is due to the processor encountering an issue communication on the local network by its assigned IP address (IP conflict). This can also attribute for issues with network communication via a faulty Ethernet switch or a lack of DHCP associations available on the router.

If assigning a Static IP, attempt utilizing the routers DHCP server to obtain an IP and confirm the issue is resolved.

This can be achieved by setting the processor to “DHCP” in the network configuration tab.
